**Flood Control Project Maintenance  
Levee Inspections**

## Maintenance Issue Types Only, Levee Inspection Report By Mile - Spring 2015

### Sacramento Maintenance Yard East Levee Yolo Bypass

Waterway	Bank	Unit Miles	Inspection Start/End	Inspector
Unit No. 01 Yolo Bypass	Left	2.01	04/15/2015 04/15/2015	Jai Lor

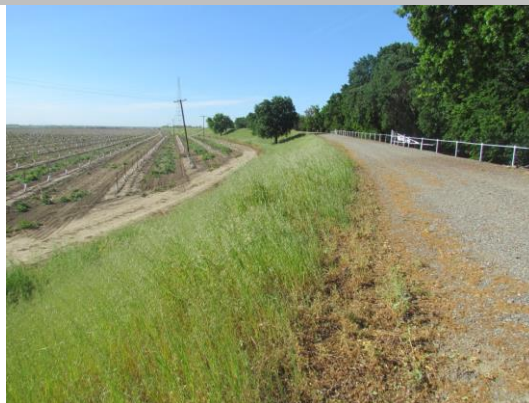
Photo 1 of 1 : SP\_2015\_ST0004\_41\_102\_20150415\_00001.jpg

LM Start	0.01	Rating **	M	Issue No.	102	
LM End	2.01	Issue Type +	Ma	Location *	LS	
Category	Earthen Levee			GPS Latitude/Longitude		
				Start		End
Item	Vegetation			38.765307 °		°
				-121.635208 °		°
DWR ID	DWR_ST0004_01_s_2015_102					
Action/Comments						
Control annual grass and weeds on the levee slopes and easements.

View of the vegetation on the landward side of the levee looking downstream. Spring 2015.

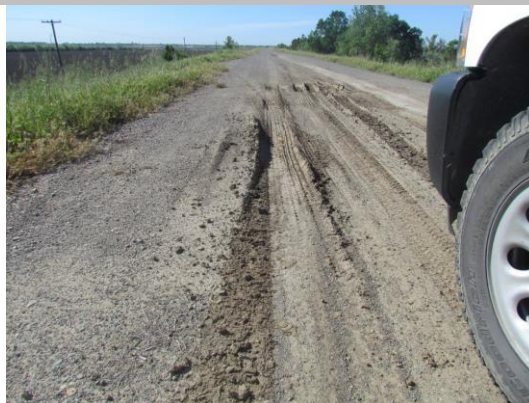
Photo 1 of 1 : SP\_2015\_ST0004\_41\_104\_20150415\_00002.jpg

LM Start	1.68	Rating **	M	Issue No.	104
LM End	2.02	Issue Type +	Ma	Location *	CR
Category	Earthen Levee			GPS Latitude/Longitude	
				Start	End
Item	Crown Surface / Depressions / Rutting			38.741080 °	38.736103 °
				-121.634018 °	-121.633682 °
DWR ID	DWR_ST0004_01_s_2015_104				
Action/Comments					
Add appropriate gravel or road base. Grade and compact.

View of the depression on the crown of the levee looking downstream. Spring 2015.
